GENERAL AVIATION STRUCTURES DIRECTLY RESPONSIBLE FOR TRAUMA IN CRASH DECELERATIONS

John J. Swearingen, D.A.V.T.
FAA Civil Aeromedical Institute
P.O. Box 25082
Oklahoma City, Oklahoma 73125

January 1971

1. Report No. FAA-AM-71-3	2. Government Accession No.	3. Recipient's Catalog No.	
4. Title and Subtitle GENERAL AVIATION STRUCTURES DIRECTLY RESPONSIBLE FOR TRAUMA IN CRASH DECELERATIONS		5. Report Date January 1971

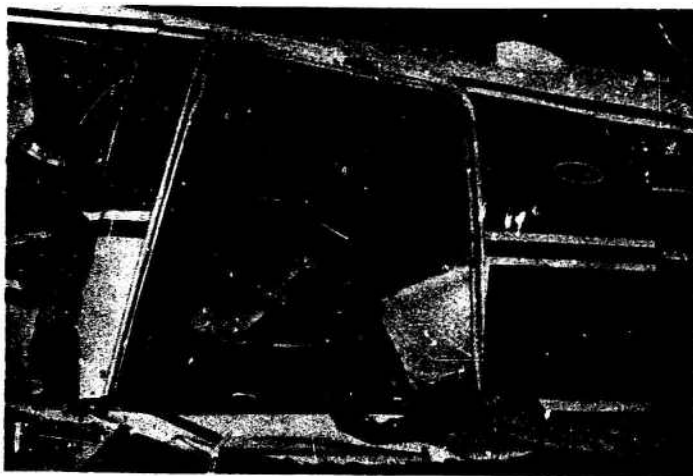
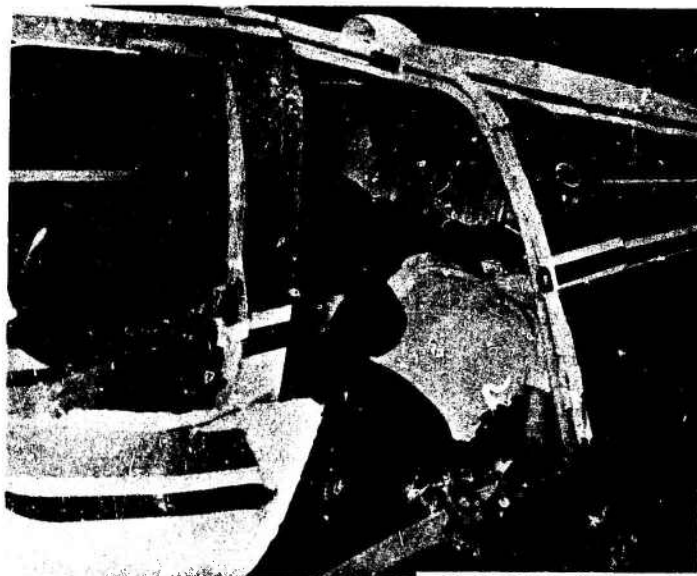
CASE 27-5

G, H & I All occupants have seat belts fastened, appear to be sitting on the ground, & died from severe internal injuries produced by vertical forces.

and repaired in time. The author⁷² has experienced vertical decelerations of up to 95 "g" for .0075 seconds with internal injuries corrected by surgery. In the same study, all subjects tolerated 220 "g" for .0065 seconds without injury or pain when the test seat was equipped with 4 inches of crushable foam under the seat pan. Judging from the massive internal injuries of the occupants in the crash case being presented here as compared to those for the fall case presented by Snyder, the peak vertical force generated when the seats bottomed out must have been in the range of 5,000 to 6,000 "g". The significant point to be made here is that the seats must not be of a frail design that allows them to crush, using up valuable deceleration distance while dissipating very little of the impact force and then bottom out against rigid structure and producing very high, intolerable "g" forces. Numerous simple methods for gradual vertical deceleration have been devised and are in use on Army helicopters. Use of energy attenuators in the design of the seats of this aircraft would have allowed the six occupants of this aircraft to survive without injury.

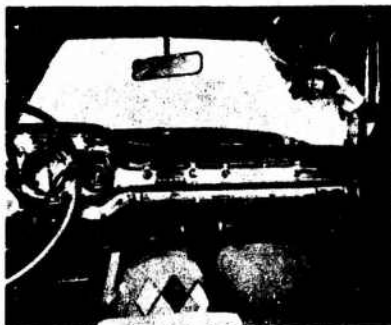
VELOCITY OF IMPACT (FT/SEC)	<u>18.1</u>
METAL THICKNESS (INCHES)	<u>.038</u>
RADIUS OF CURVATURE AT POINT OF IMPACT (INCHES)	<u>19</u>
PADDED	<u>NO</u>
MAXIMUM DEPRESSION: DEPTH (INCHES)	<u>1 1/2</u>
AREA (SQ. INCHES)	<u>101.8</u>
YEAR AND MAKE OF CAR	<u>59 PONTIAC</u>

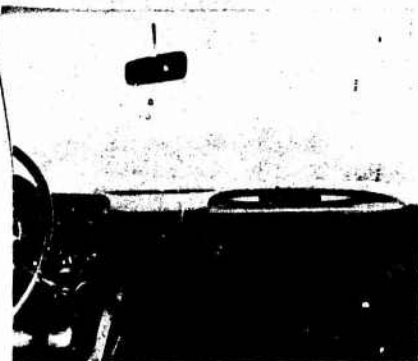
VELOCITY OF IMPACT
(FT/SEC) 18.5

METAL THICKNESS
(INCHES)040

AREA (SQ. INCHES) 182.7

YEAR AND MAKE OF CAR 60 CHEV

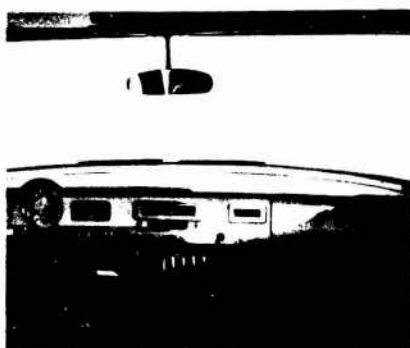
VELOCITY OF IMPACT (FT/SEC)	<u>24.4</u>
METAL THICKNESS (INCHES)	<u>0.39</u>
RADIUS OF CURVATURE AT POINT OF IMPACT (INCHES)	<u>13</u>
PADDED	<u>NO</u>
MAXIMUM DEPRESSION DEPTH (INCHES)	<u>1 1/8</u>
AREA (SQ INCHES)	<u>73.0</u>
YEAR AND MAKE OF CAR	<u>54 DODGE</u>

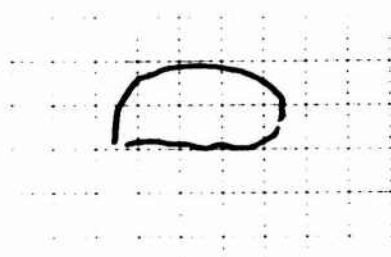
AFTER IMPACT

VELOCITY OF IMPACT (FT/SEC)	<u>25.0</u>
METAL THICKNESS (INCHES)	<u>.042</u>
RADIUS OF CURVATURE AT POINT OF IMPACT (INCHES)	<u>1/8</u>
PADDED	<u>NO</u>
MAXIMUM DEPRESSION: DEPTH (INCHES)	<u>1 1/8</u>
AREA (SQ. INCHES)	<u>6.0</u>
YEAR AND MAKE OF CAR	<u>55 CHEV</u>

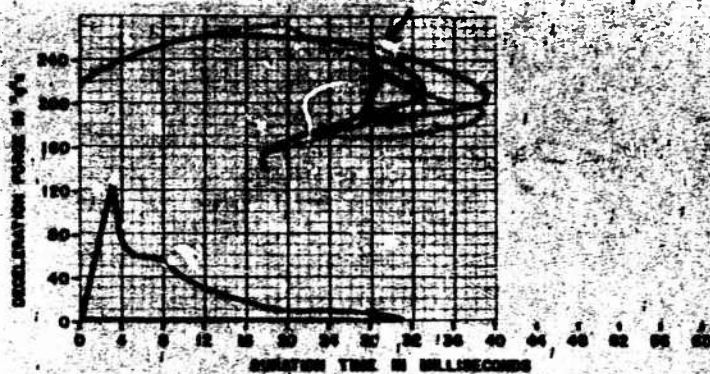
VELOCITY OF IMPACT (FT/SEC)	27.5
METAL THICKNESS (INCHES)	.038
RADIUS OF CURVATURE AT POINT OF IMPACT (INCHES)	10 ³ / ₄
PADDED LIP	
MAXIMUM DEPRESSION: DEPTH (INCHES)	1 ¹ / ₂
AREA (SQ. INCHES)	45.4
YEAR AND MAKE OF CAR	61 PONTIAC

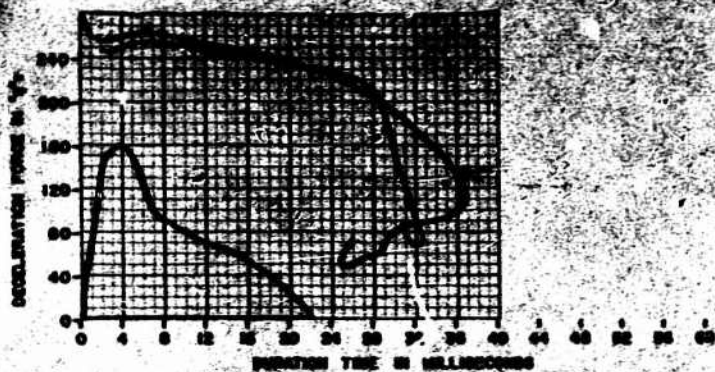
VELOCITY OF IMPACT (FT/SEC)	<u>30.1</u>
METAL THICKNESS (INCHES)	<u>.039</u>
RADIUS OF CURVATURE AT POINT OF IMPACT (INCHES)	<u>3/4</u>
PADDED	<u>NO</u>
MAXIMUM DEPRESSION: DEPTH (INCHES)	<u>1 1/4</u>
AREA (SQ. INCHES)	<u>56.7</u>
YEAR AND MAKE OF CAR	<u>57 ORD</u>

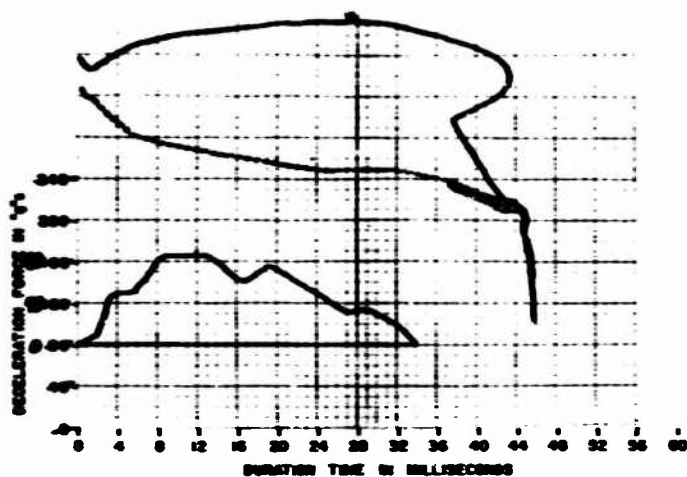
AFTER IMPACT

VELOCITY OF IMPACT (FT/SEC)	<u>42.6</u>
METAL THICKNESS (INCHES)	<u>.039</u>
RADIUS OF CURVATURE AT POINT OF IMPACT (INCHES)	<u>14 1/4</u>
PADDED	<u>NO</u>
MAXIMUM DEPRESSION: DEPTH (INCHES)	<u>3 3/4</u>
AREA (SQ. INCHES)	<u>150.7</u>
YEAR AND MAKE OF CAR	<u>57 FORD</u>
